# Manhole Inspection Summary

Manhole # S21A1\_002MH

Insp Date: **5/18/08 12:59 PM**

**Location** Address: **2229 hollins ferry rd**

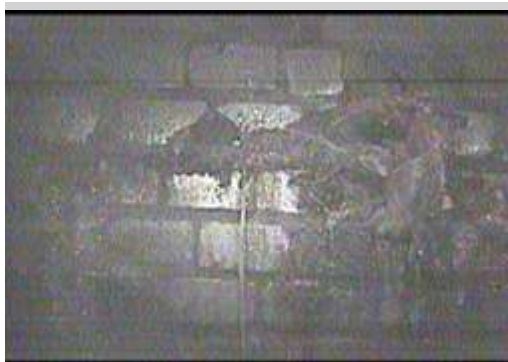
Defect 4

Infiltration: ☐ None ☐ Joint ☐ Cracks ☐ Mortar ☐ Roots ☒ **Wall**

☒ **Evidence Of Surcharge** Depth: **5** (ft.) ☐ Active Surcharge Present

surcharge evidence, barrel infiltration from wall

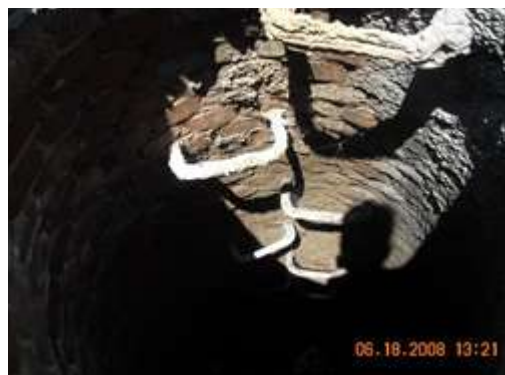
Defect 3

Count: **11** Missing: **0** ☒ **Corroded**

corroded steps

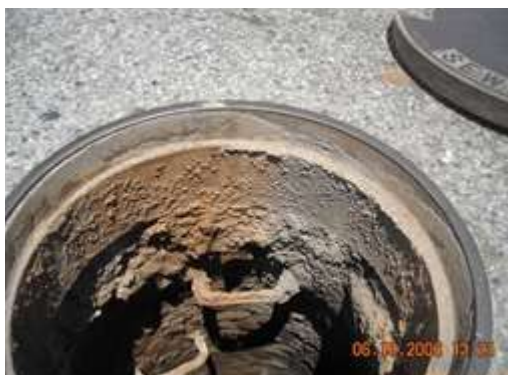
Defect 2

inflow evidence from sheeting

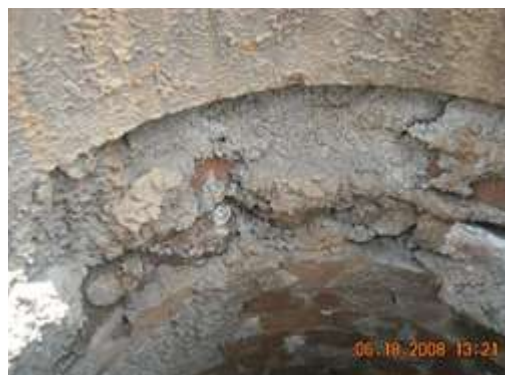
Defect 1

Condition: ☐ Sound ☐ Cracked ☐ Root Intrusion ☐ Loose Brick ☒ **Deteriorated**

deteriorated chimney

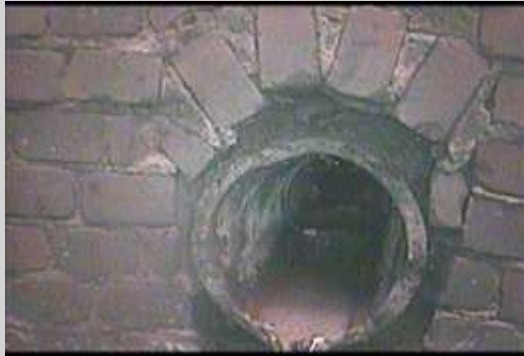
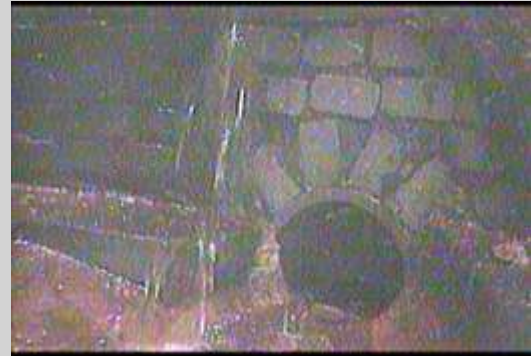
7 O'Clock Inflow

Pipe Seal Cond: **Broken**

Drop Condition: **Partly Clogged**
